2012 Aquatic Weed Survey and Water Quality Analysis of Hickory Hills Lake

Hickory Hills Landowners, Inc.
Lake Management Group
PO Box 298
Lunenburg, MA 01462

Aquatic Control Technology, Inc.
11 John Road
Sutton, MA 01590

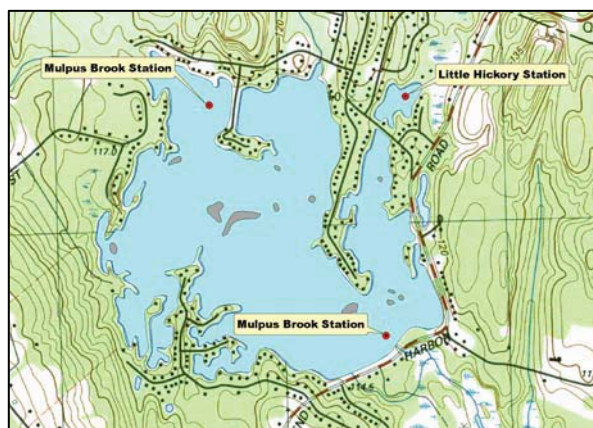
Figure 2 – Sampling Locations

On August 24th, samples were collected from three stations in the lake (see Figure 2 – Left) corresponding to the Mulpus Brook Cove, the main lake near the outlet and Little Hickory. The results of the laboratory analyses are provided in the table below followed by a brief description of the parameter and interpretation of the data.

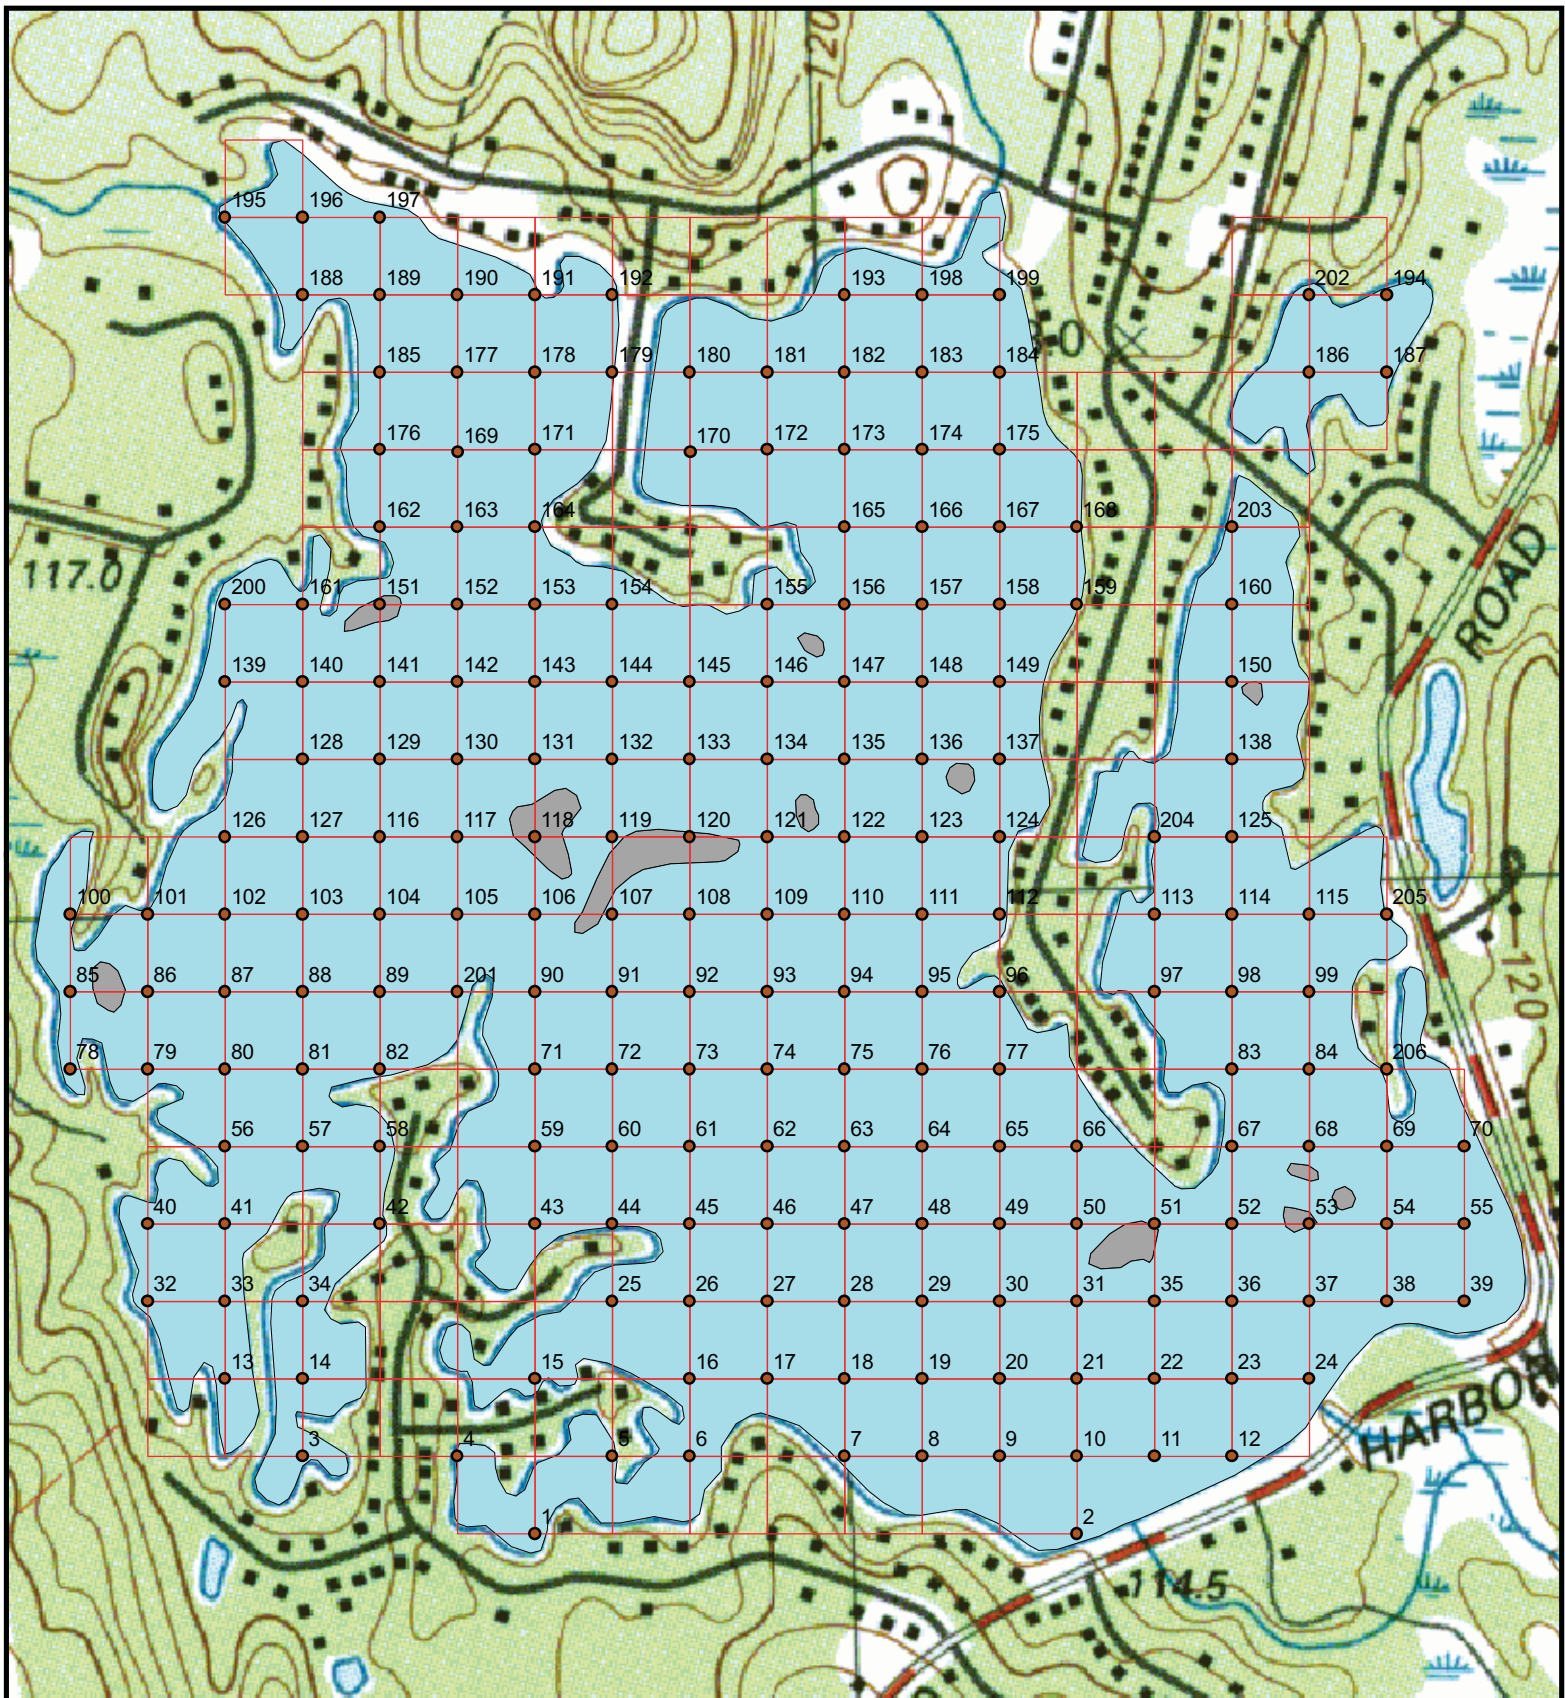
Task	Description
Aquatic Vegetation Assessment and Measurements of Water Depth	Pre-determined sample points were located at the vertexes of an 80-meter grid (See Attachment A - Map 2) and downloaded into a handheld Garmin GPS unit. At each point, water depth was measured with Lowrance sonar unit. Data was collected on species type, relative abundance and biomass. Vegetation was observed visually and with the aid of an underwater camera system. Plants were physically sampled with a throw-rake as necessary, except in areas of known fanwort growth.
Water Quality Sampling	Water quality samples were collected at three locations – one near the lake outlet, one from the Mulpus Brook inlet cove and one from Little Hickory Lake.
Field WQ Measurements	At each sample location, field measurement of temperature, dissolved oxygen and water clarity were performed. Samples were collected from each station for algal identification and enumeration. One sample was collected from the lake outlet station for zooplankton identification/enumeration.

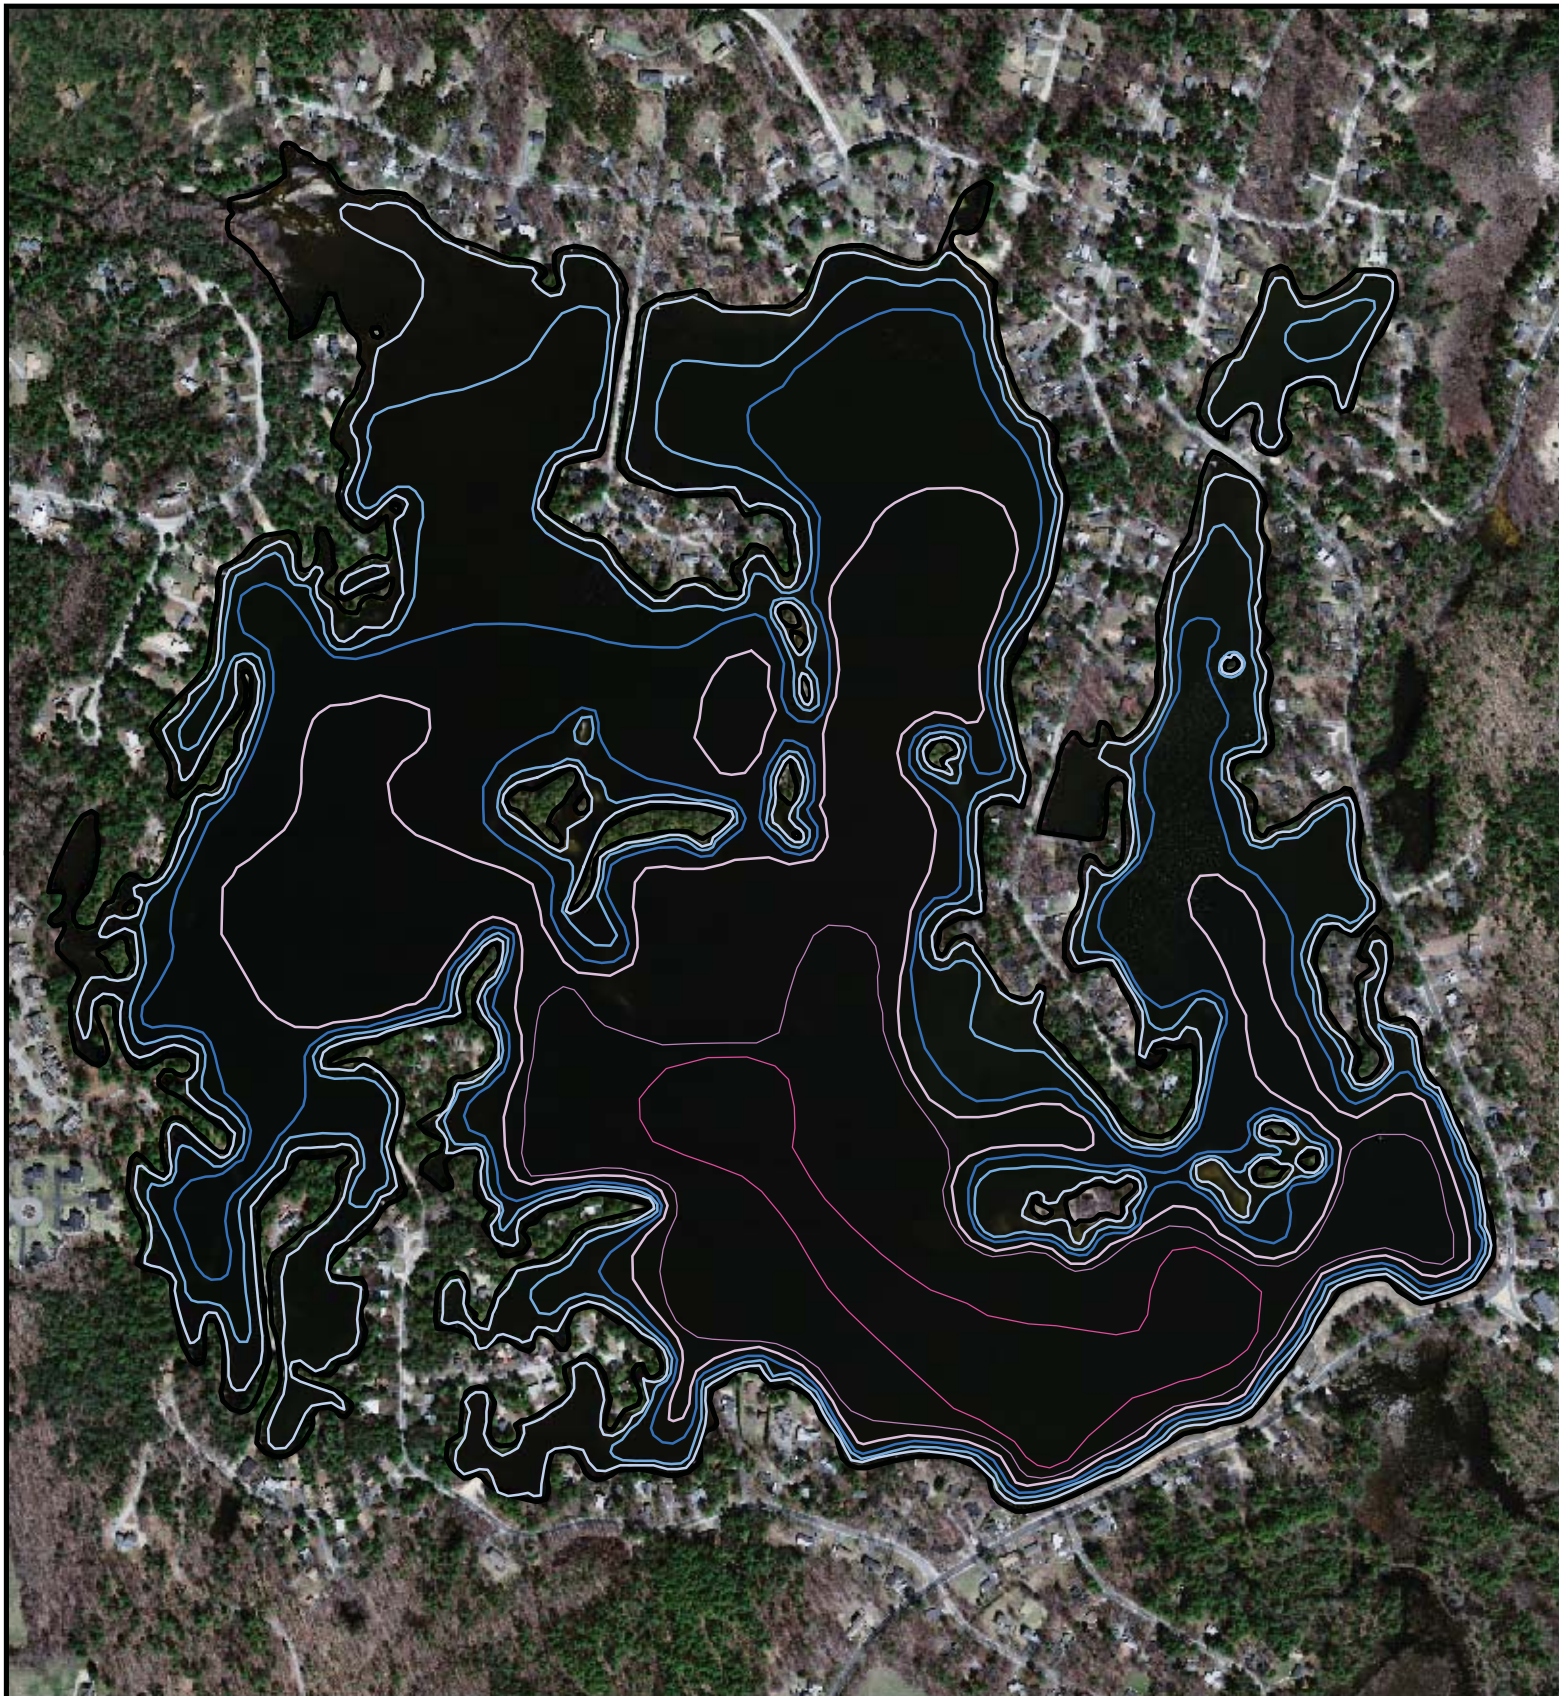
Water depth data collected at each sample point was used to produce a contour map of the lake’s bathymetry (See Attachment A - Map 3). The maximum water depth observed in the lake was 20-feet and the average was approximately 10.4-feet. As a benchmark, at the time of the survey, the water level was ~4-feet below the top of the concrete structure housing the low level outlet control.

The accuracy of the bathymetry map is based on the discrete number of data points and the precision of the measuring equipment and should not be considered an exact depiction of water depths in the lake or used for navigational purposes. It is however useful to visualize the bottom contours of the lake and to determine the size and extent of the littoral zone and other depth-related characteristics.

Given the bathymetry of Hickory Hills Lake, increasing the drawdown from 1.5-feet to 3.0-feet will marginally expand the zone of control along the shoreline and still will not expose any large areas except for parts of the Mulpus Brook inlet area and the cove area behind the "marina" on the western side of the lake. According to Table 2, a three-foot drawdown would expose ~32.4 acres of the lake bottom and retain ~72% of the lake water volume. Due to ice scour, plant control may extend an additional 6-12 inches below the actual lowered level of the lake. A six foot drawdown would expose significantly more area – 24.2% but only leave ~46% of the total lake water volume.

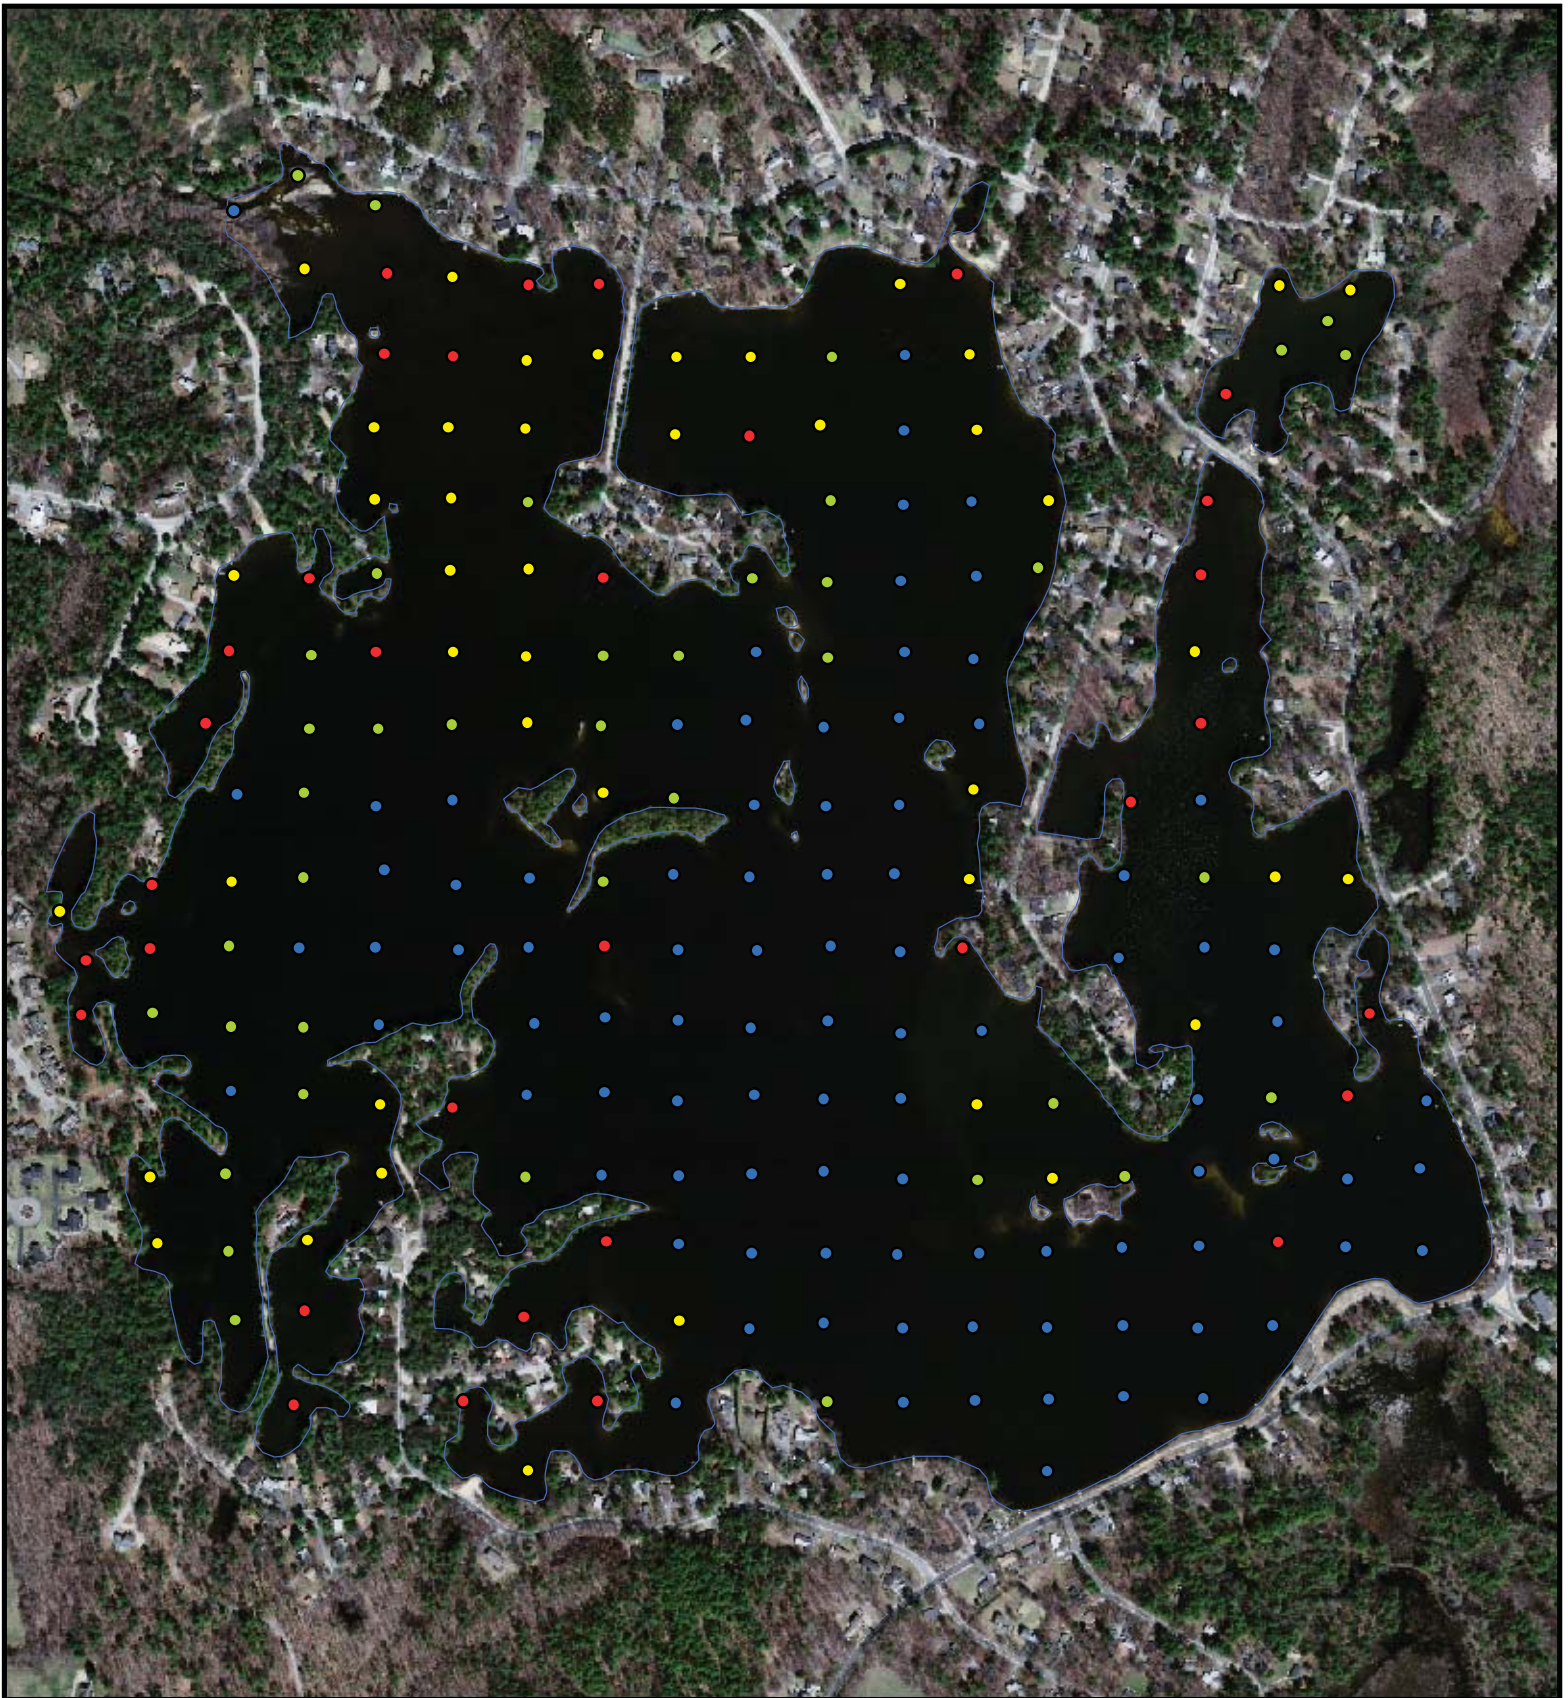
species and only about 3-4% of the plant cover in the lake is from floating leaf species, waterlilies and watershield. Map 4 shows the total percent plant cover (not including algae) at each data point.

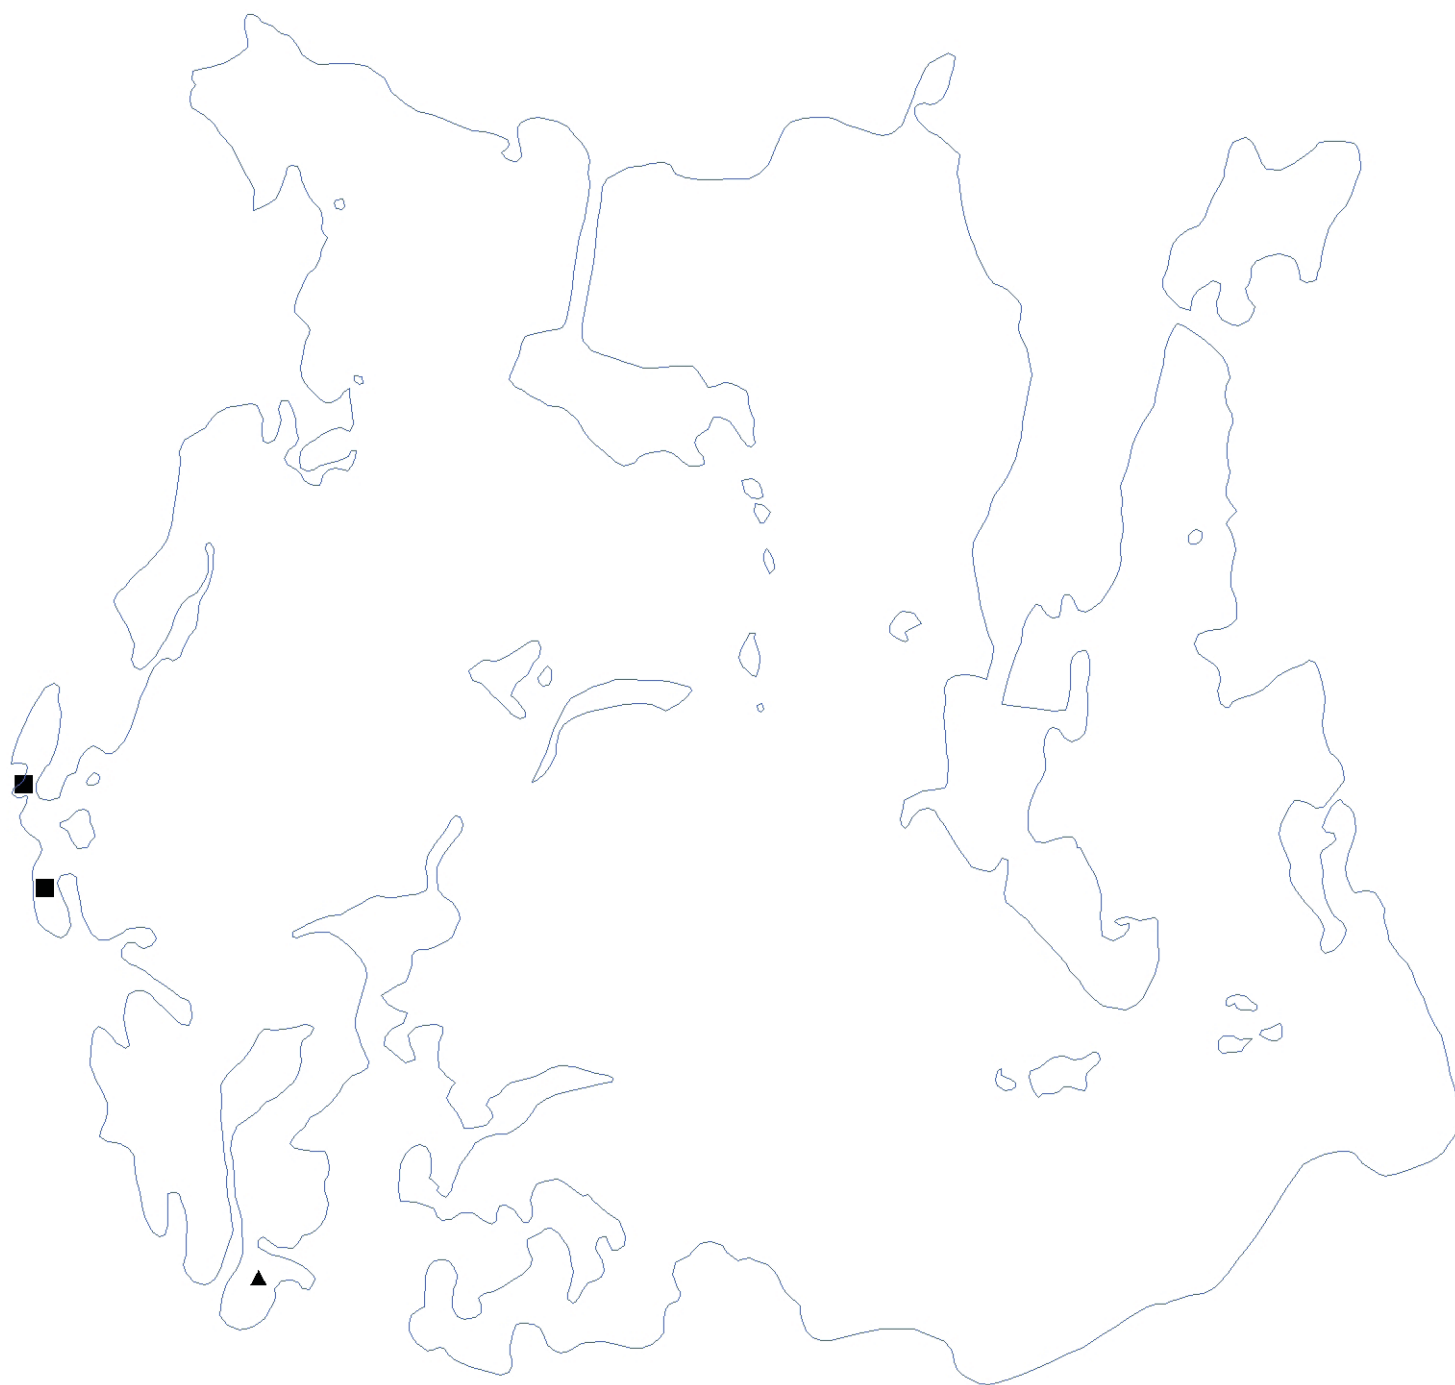
Locations and Biomass of Mermaidweed

A concern arose following the 2010 survey project when Mermaid weed was observed to have spread from its historical location and extent in Proctors Cove outwards toward the main lake. Although

mermaid weed is a native plant species, it does tend towards more dense and higher biomass growth and thus has the potential to increase nuisance conditions in parts of the lake. Fortunately, no further spread of mermaid weed was observed during this year's survey.

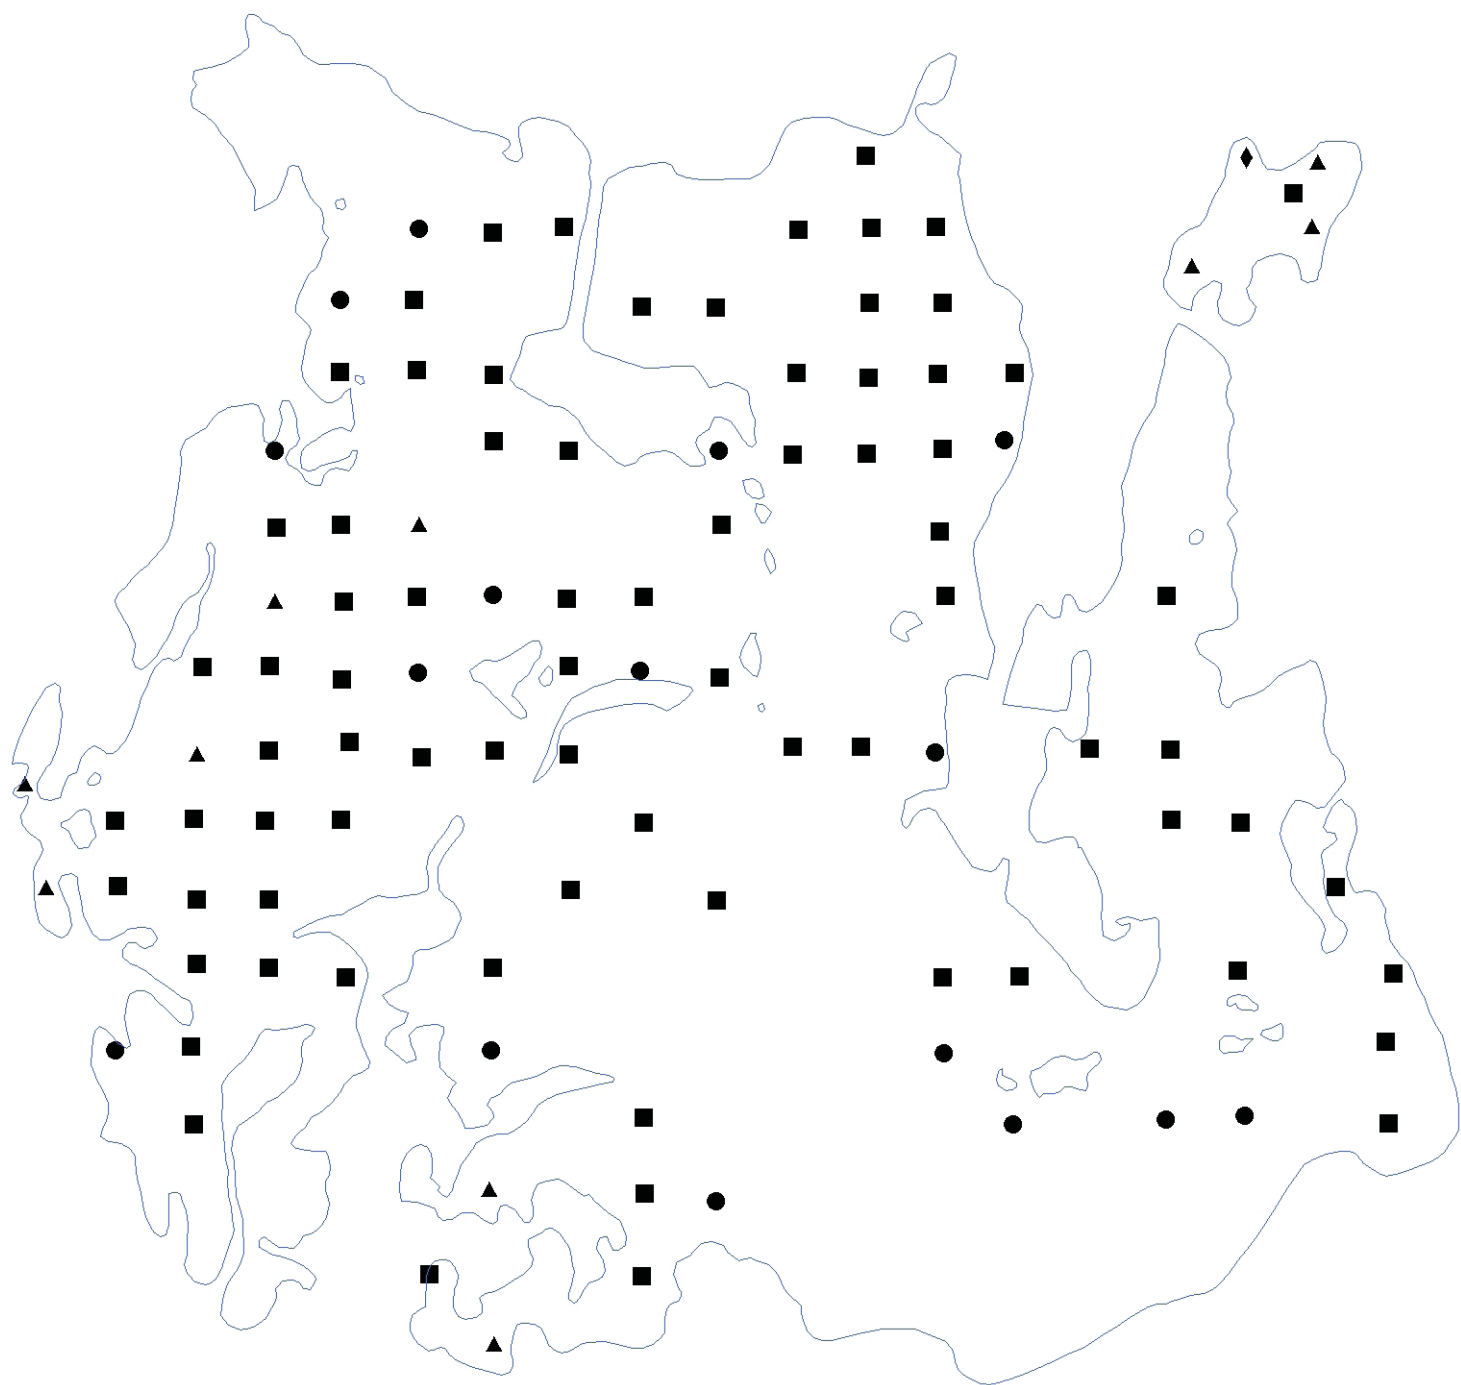
Map 5k

A number of maps are attached (Map 5a-r) showing the location and biomass of each observed species. Bladderwort continues to be the dominant plant in the lake, however aside from stonewort, Robbins pondweed is now the second most commonly occurring plant in the lake. Tapegrass is less common, but exhibits a higher growth density, coming in second in lake wide average percent cover when stonewort is excluded.

Locations and Biomass of Robbins Pondweed

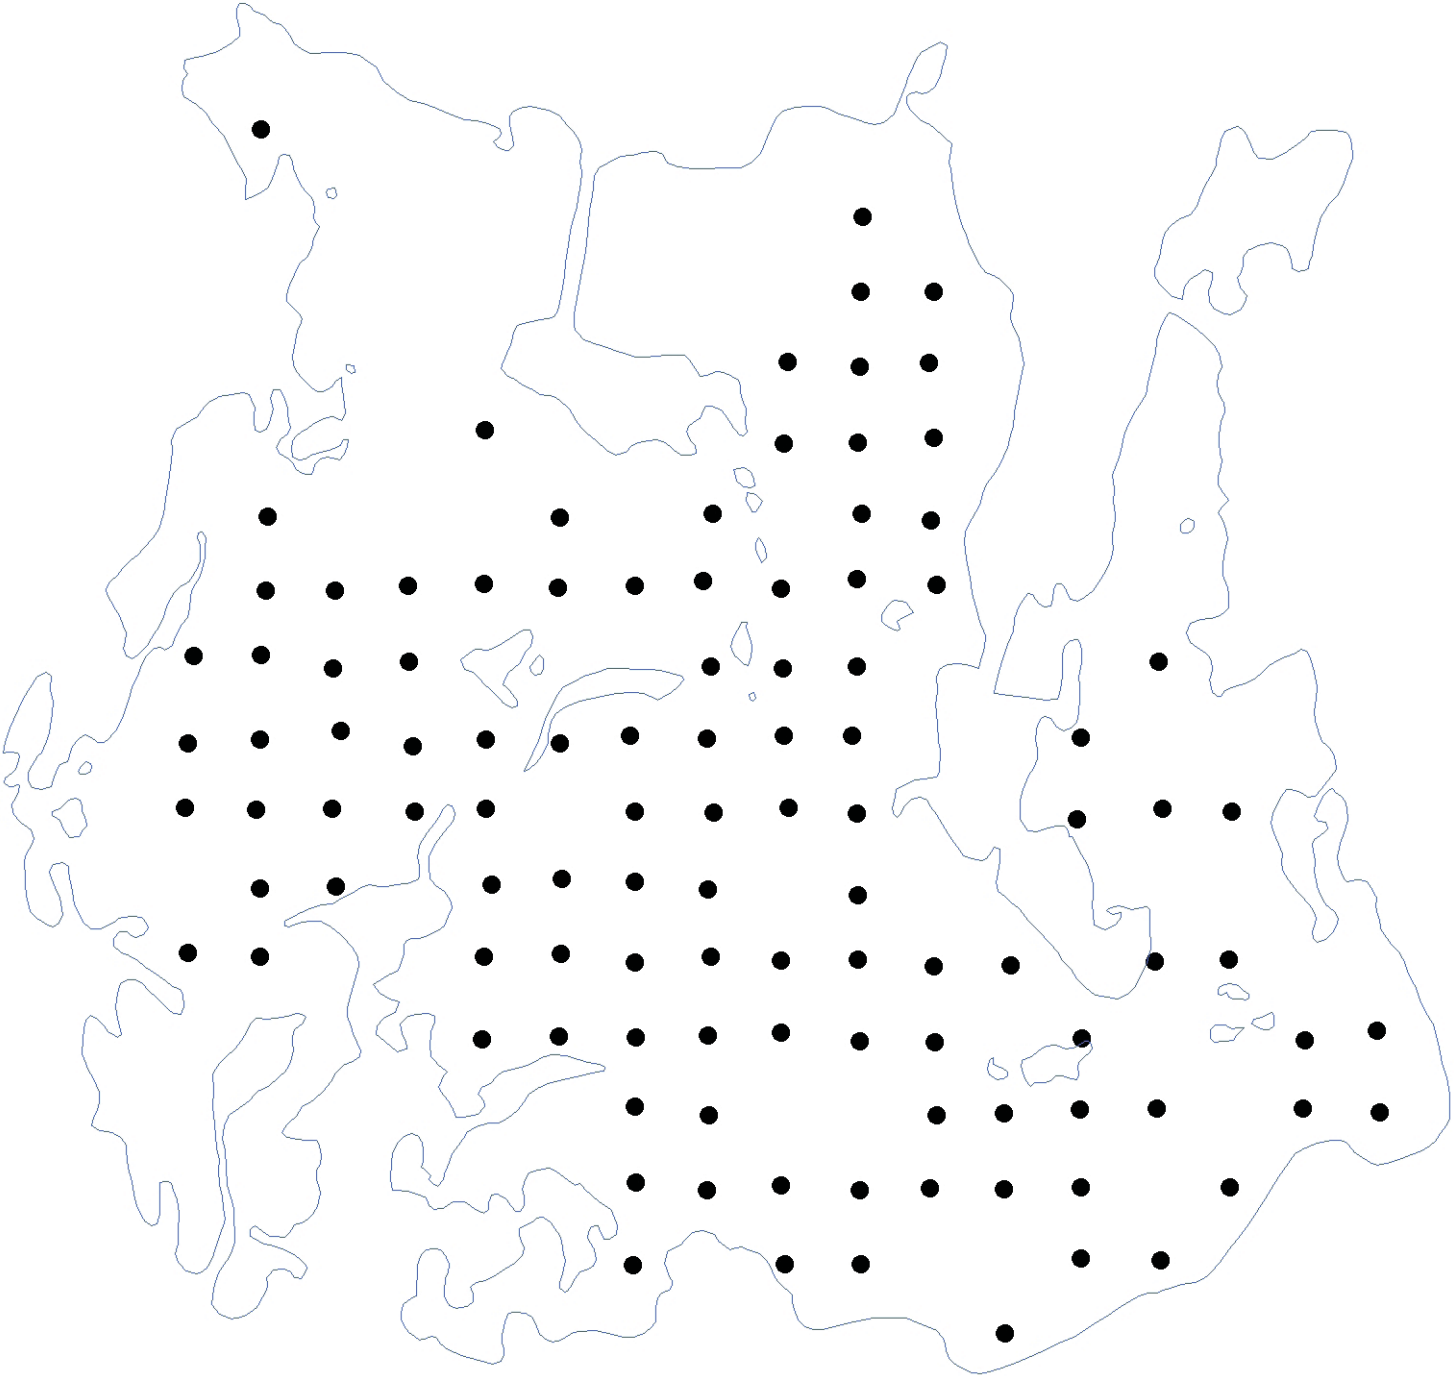
Locations and Biomass of Stonewort

Overall, about 62.5% of the bottom in Hickory Hills Lake is covered with plant growth. If you do not include algae growth (filamentous or macro forms, i.e. stonewort), which occur mainly in the deeper areas, the percent bottom cover drops to ~40%. A majority of this growth is made up of submersed
