Aquatic Weed Survey and Water Quality Analysis of Hickory Hills Lake

2014 Project Completion Report

Hickory Hills Landowners, Inc.
Lake Management Group
PO Box 298
Lunenburg, MA 01462

AQUATIC CONTROL TECHNOLOGY

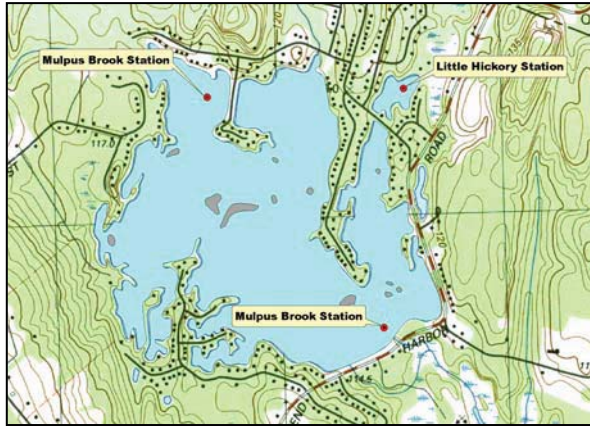
Figure 2 – Sampling Locations

On September 16th, samples were collected from three stations in the lake (see Figure 2 – Left) corresponding to the Mulpus Brook Cove, the main lake near the outlet and Little Hickory. The results of the laboratory analyses are provided in the table below followed by a brief description of the parameter and interpretation of the data.
